REPORT NO.
UCB/EERC-97/13
DECEMBER 1997
59A131

FATIGUE LIFE EVALUATION OF CHANGEABLE MESSAGE SIGN STRUCTURES

VOLUME 2: RETROFITTED SPECIMENS

Report to the California Department of Transportation
for Research under Contract RTA-59A131

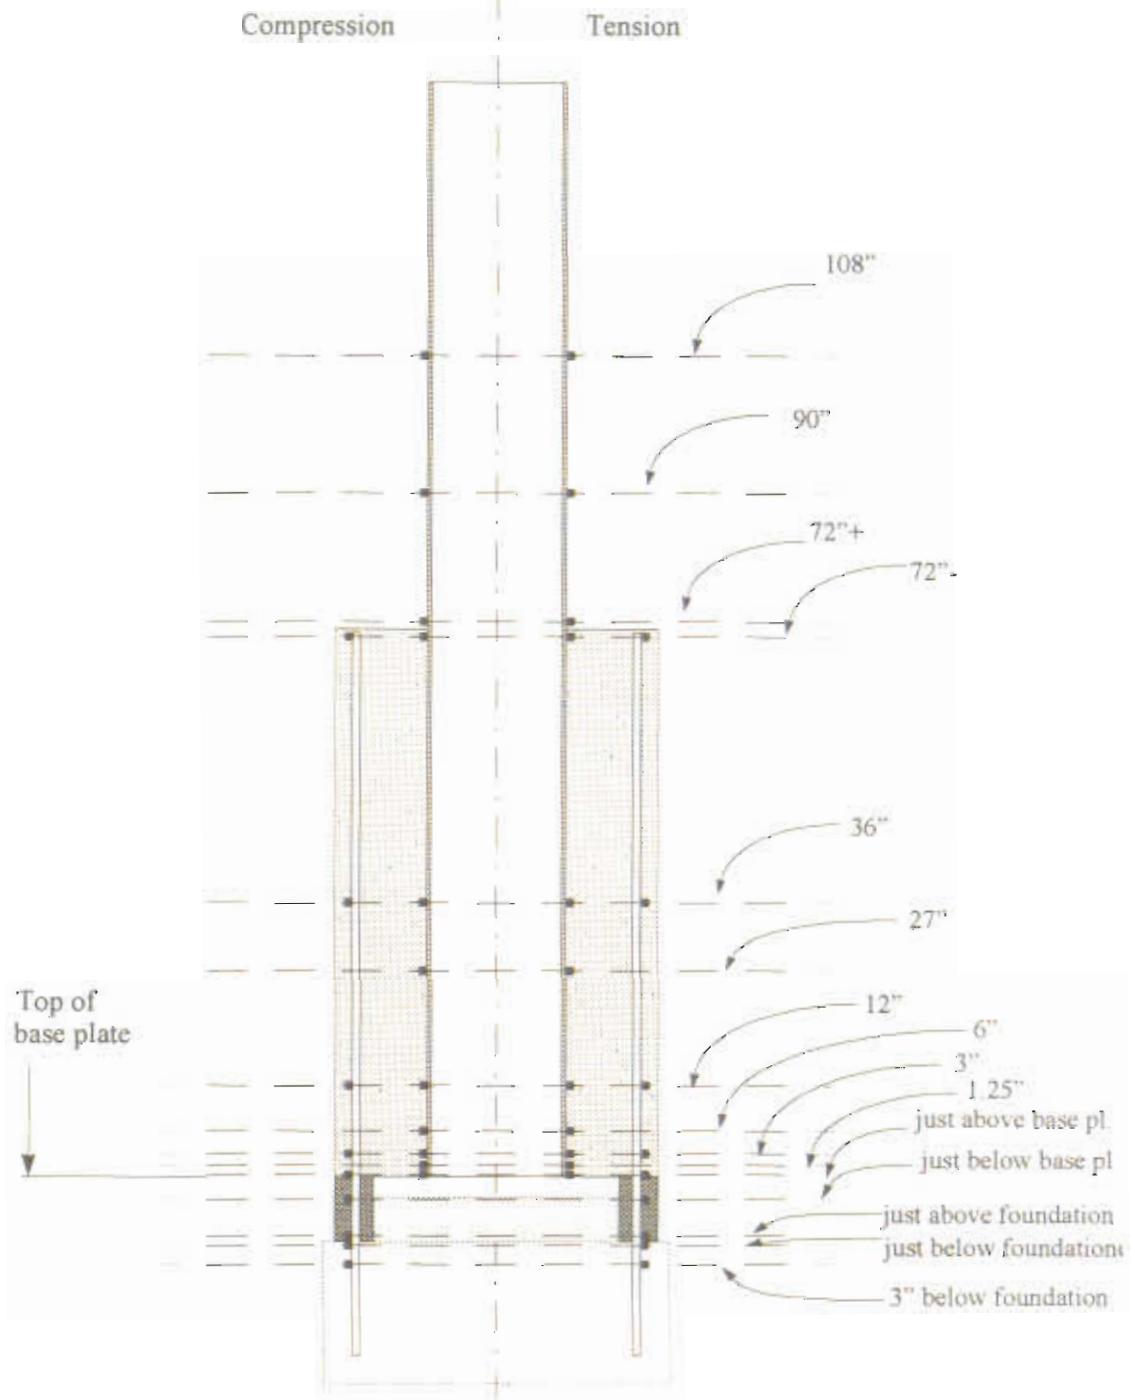
Figure 5.13: Schematic view of longitudinal strain gages on the post and jacket reinforcement

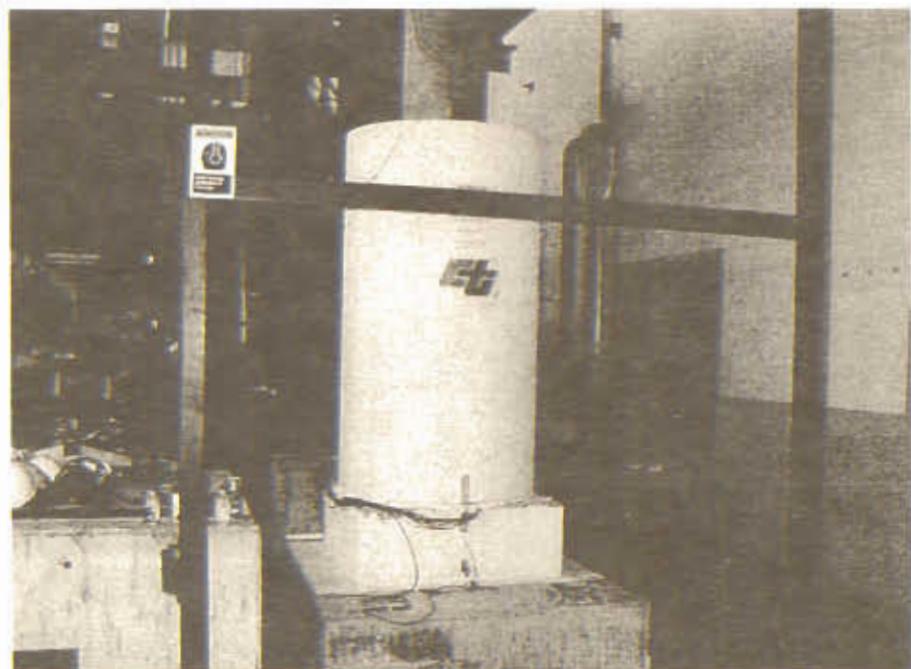
Figure 5.14: Photograph of Specimen CIP1 prior to cyclic testing

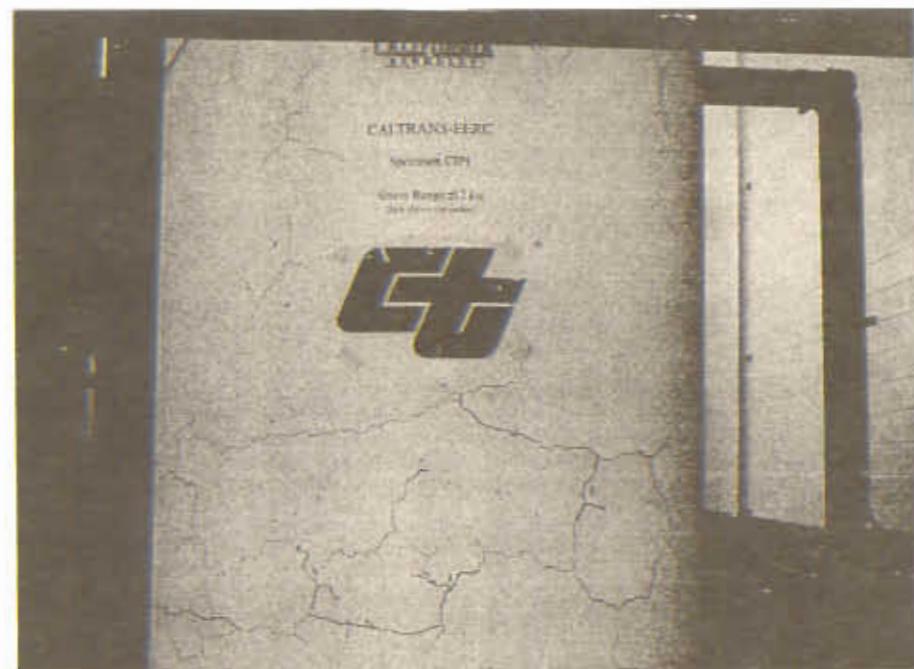
Figure 5.15: Photograph of Specimen CIP1 at the conclusion of the cyclic testing

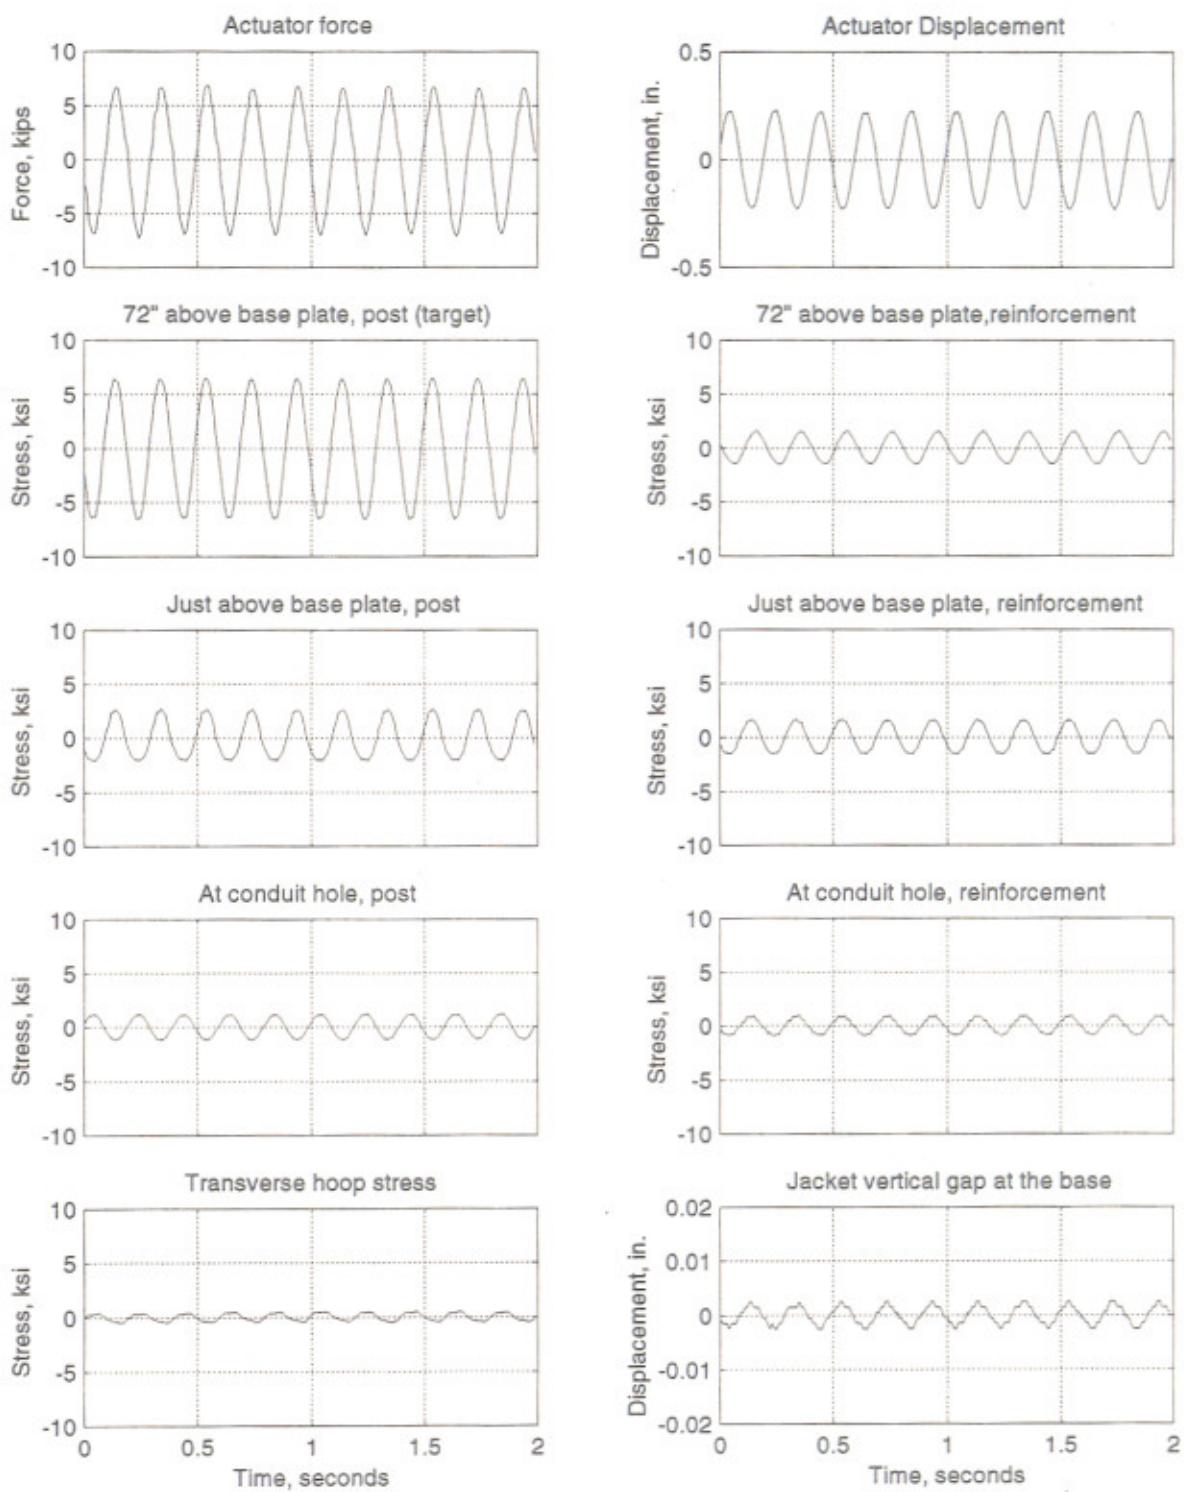
Figure 5.16: Typical response histories for Specimen CIP1

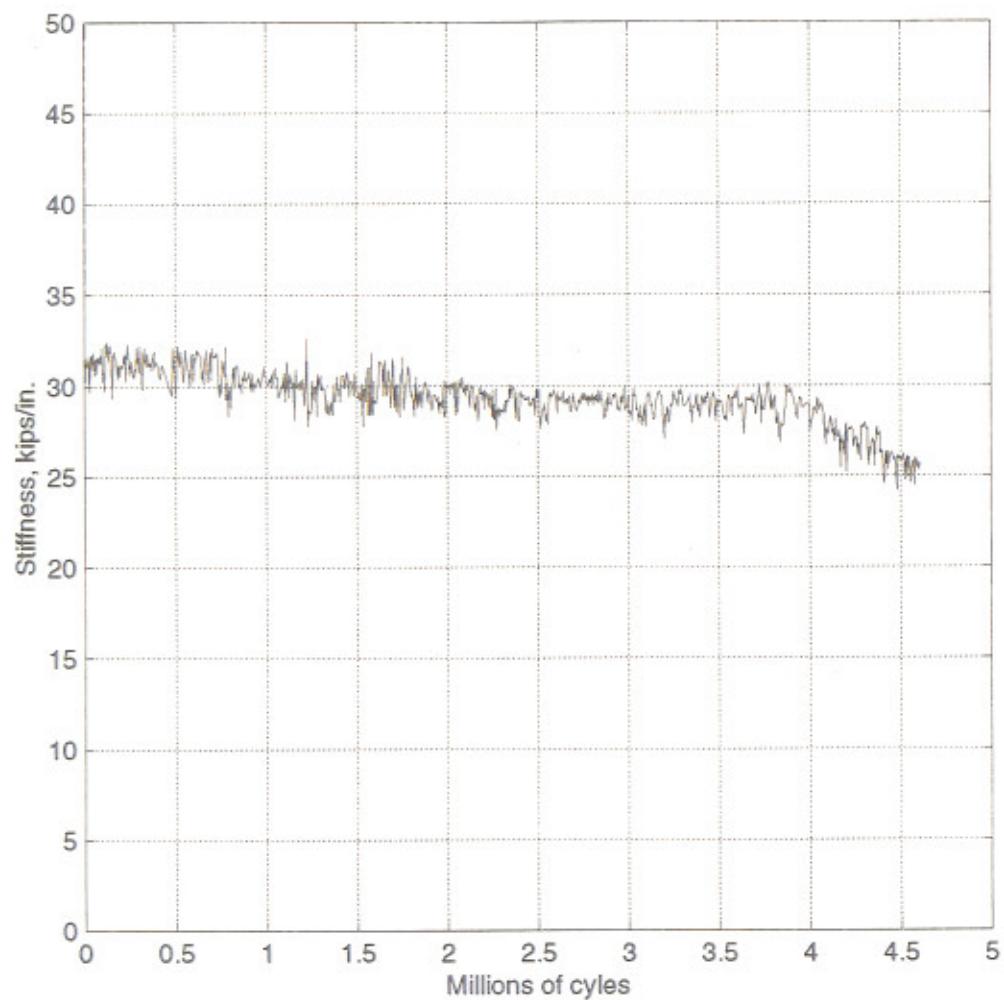
Figure 5.17: Lateral stiffness history for Specimen CIP1

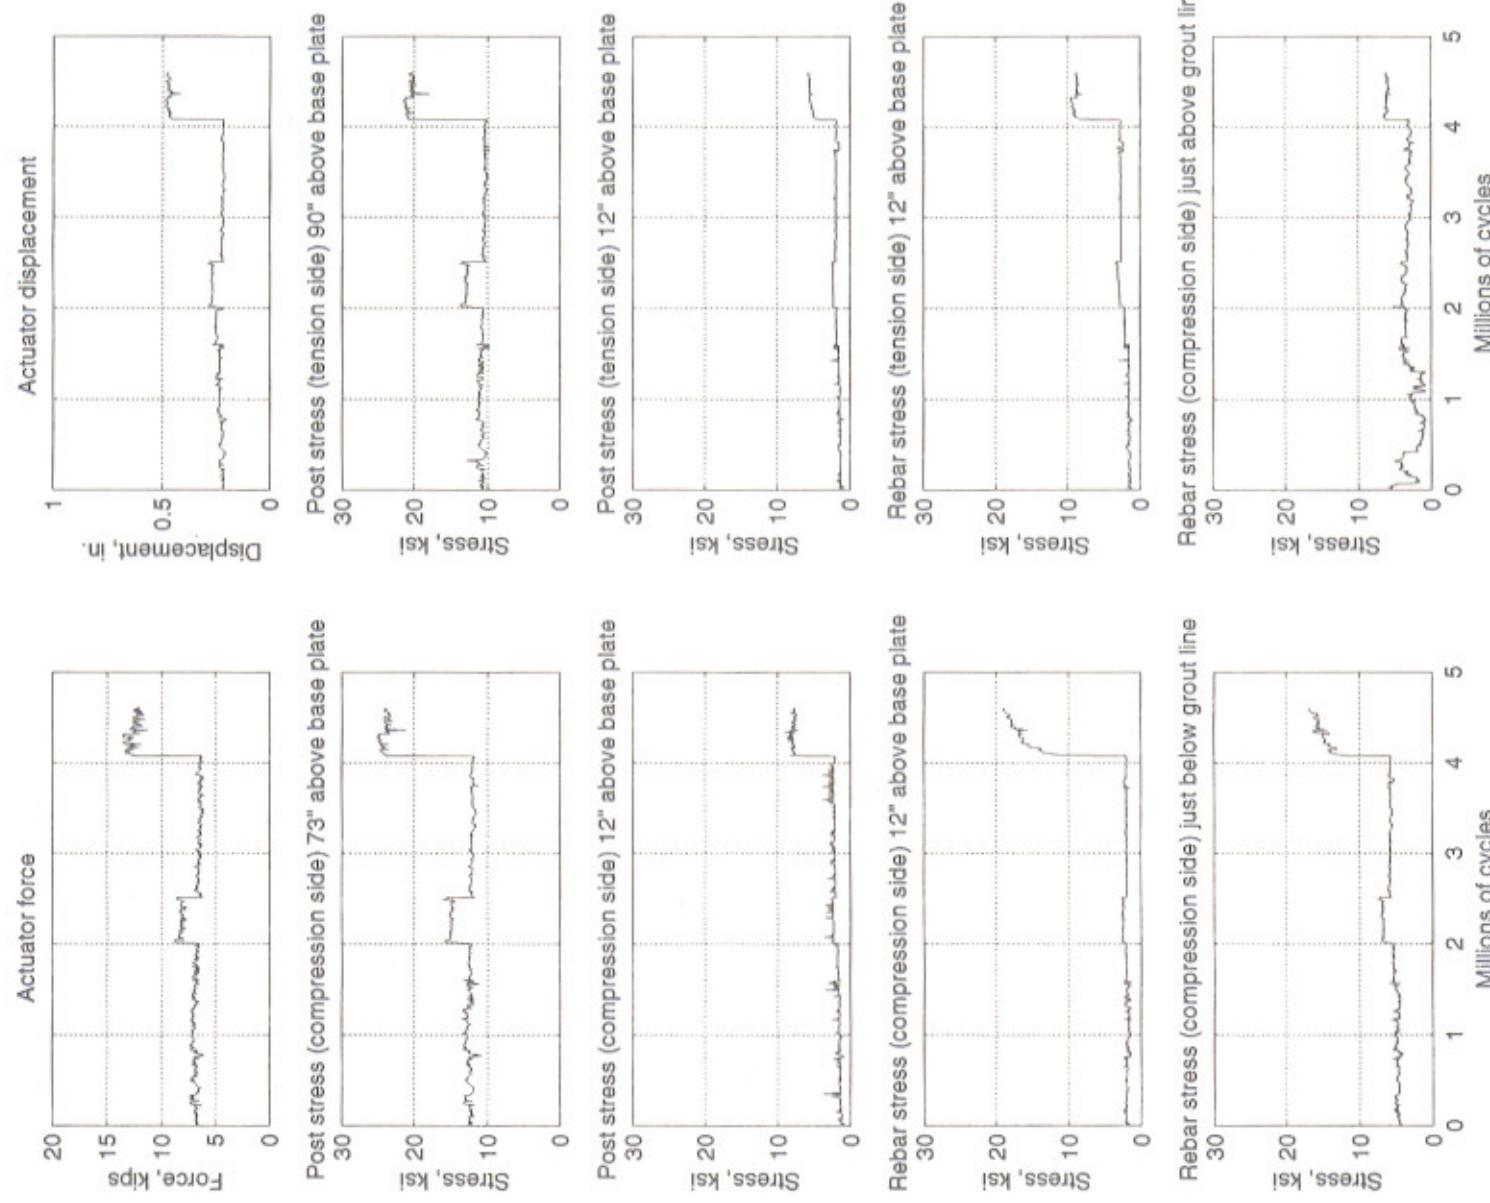
Figure 5.18: Response maxima for Specimen CIP1

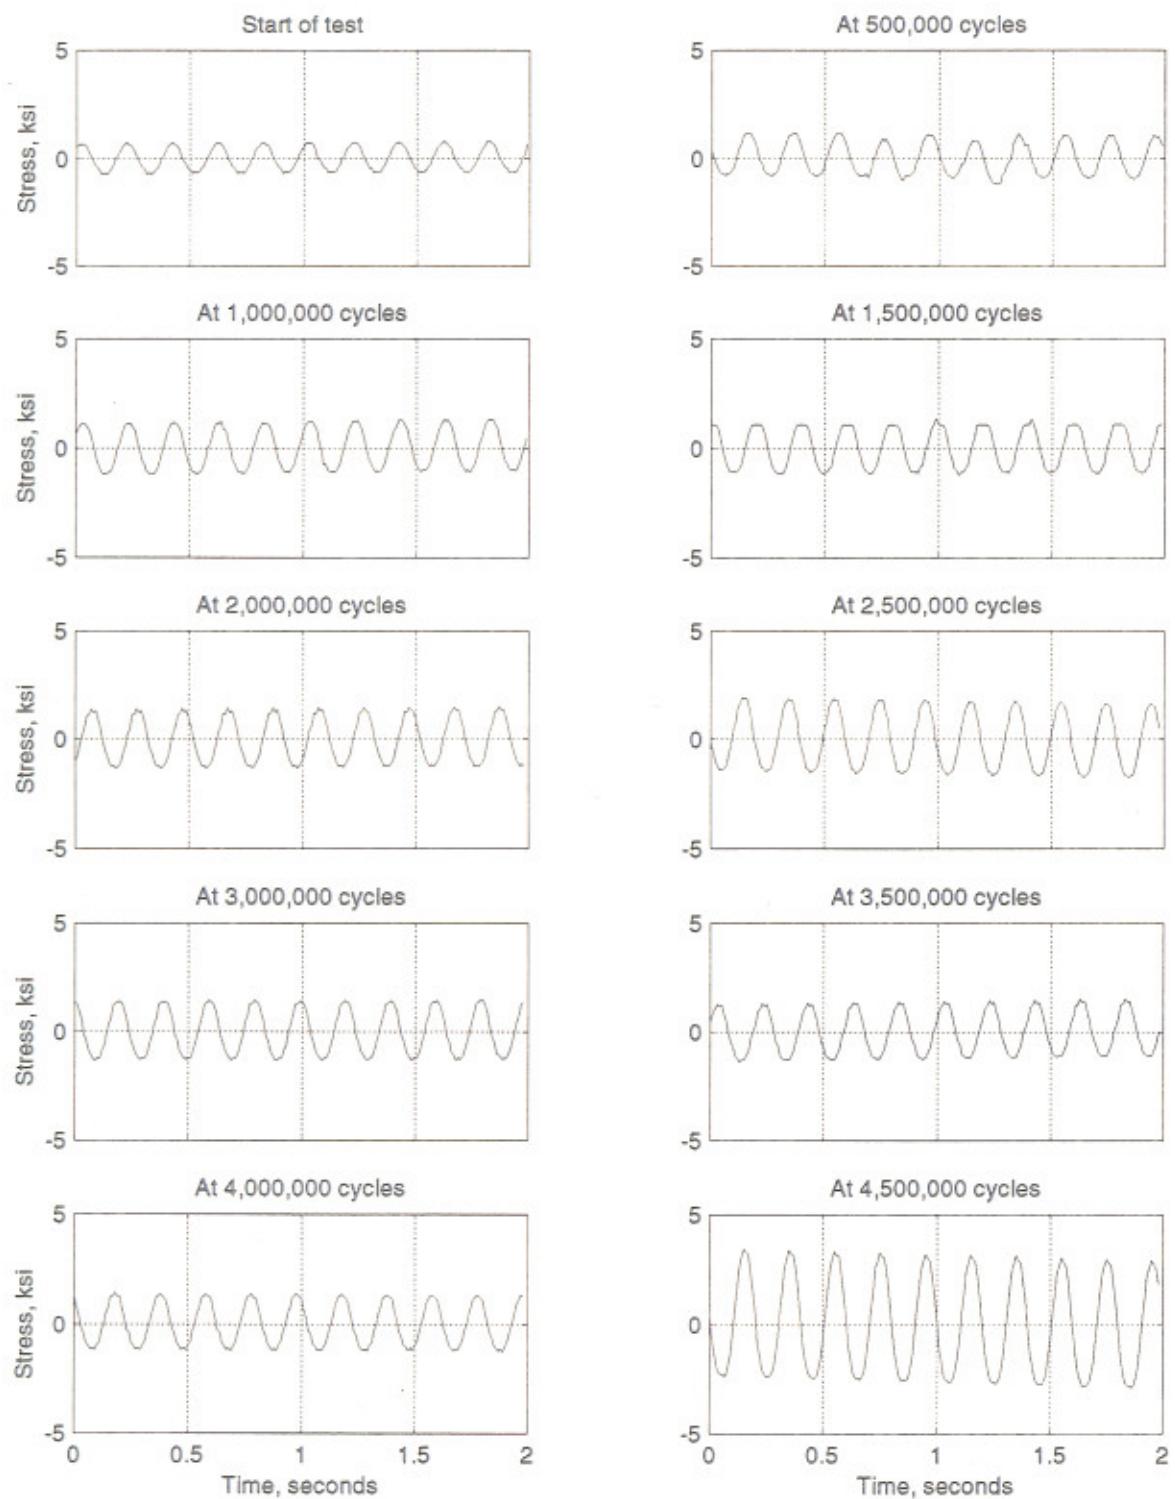
Figure 5.19: Post stress history at 3 in. above the base plate (sg3) for Specimen CIP1

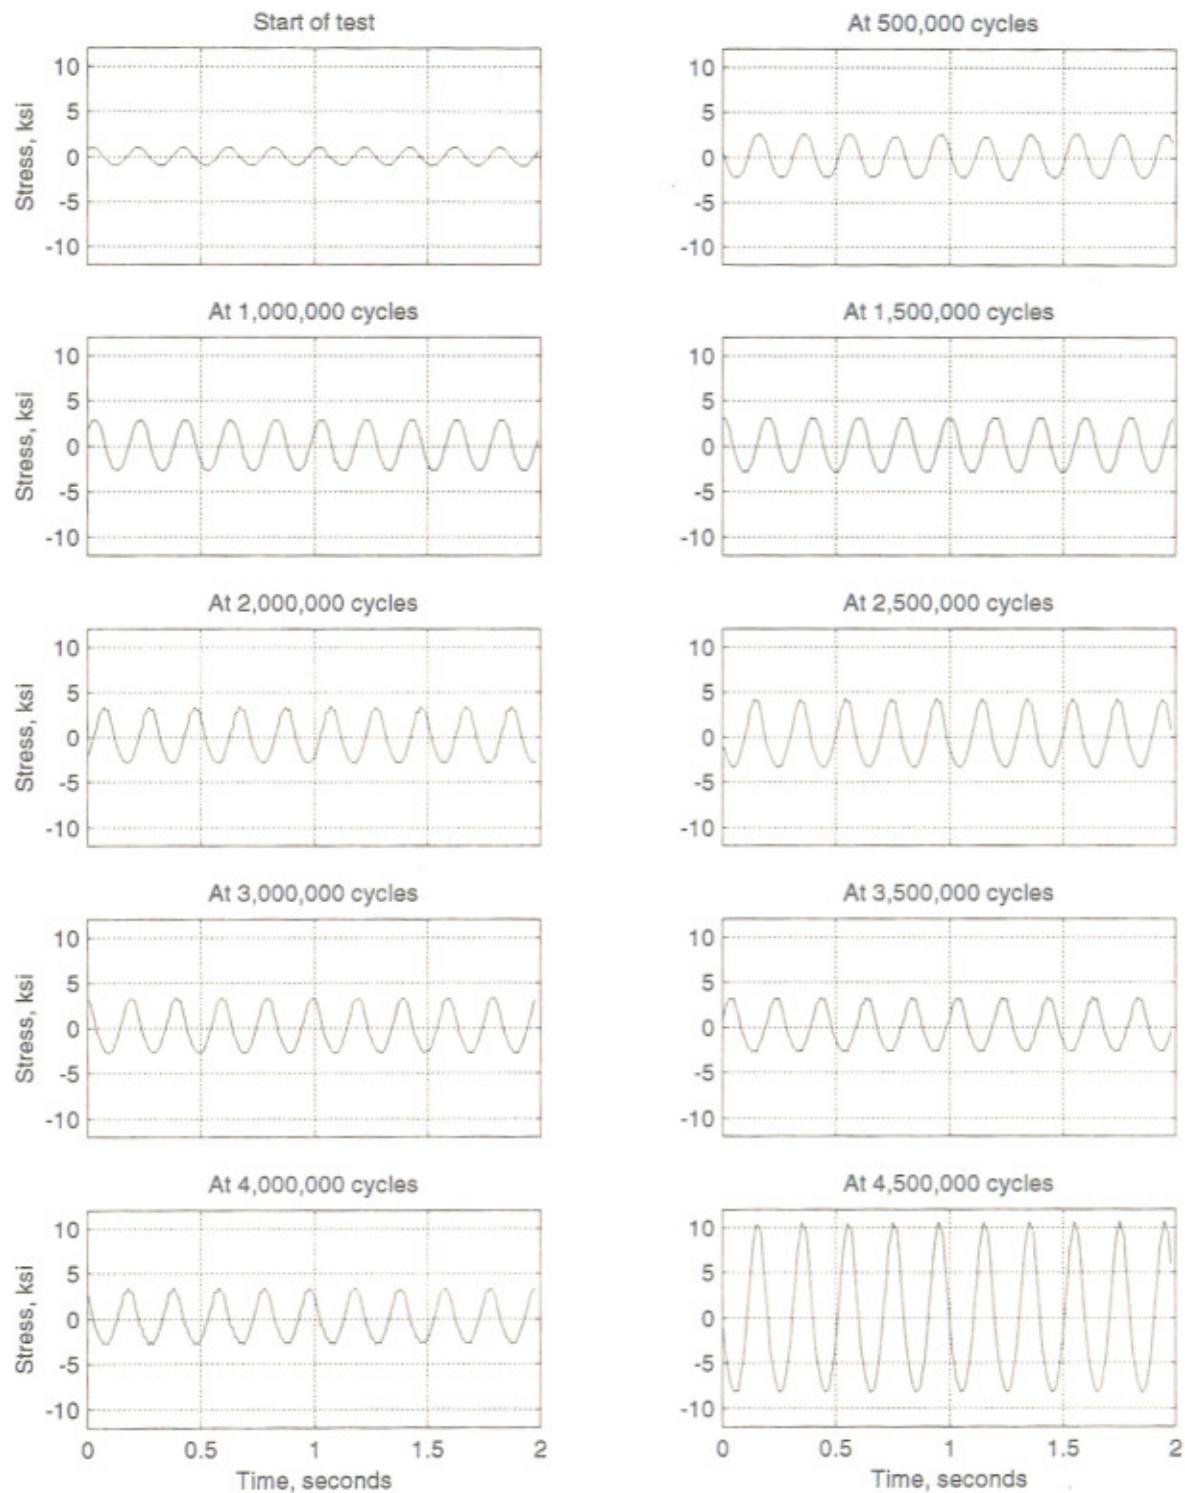
Figure 5.20: Reinforcement stress history at 3 in. above the base plate (sg33) for Specimen CIP1

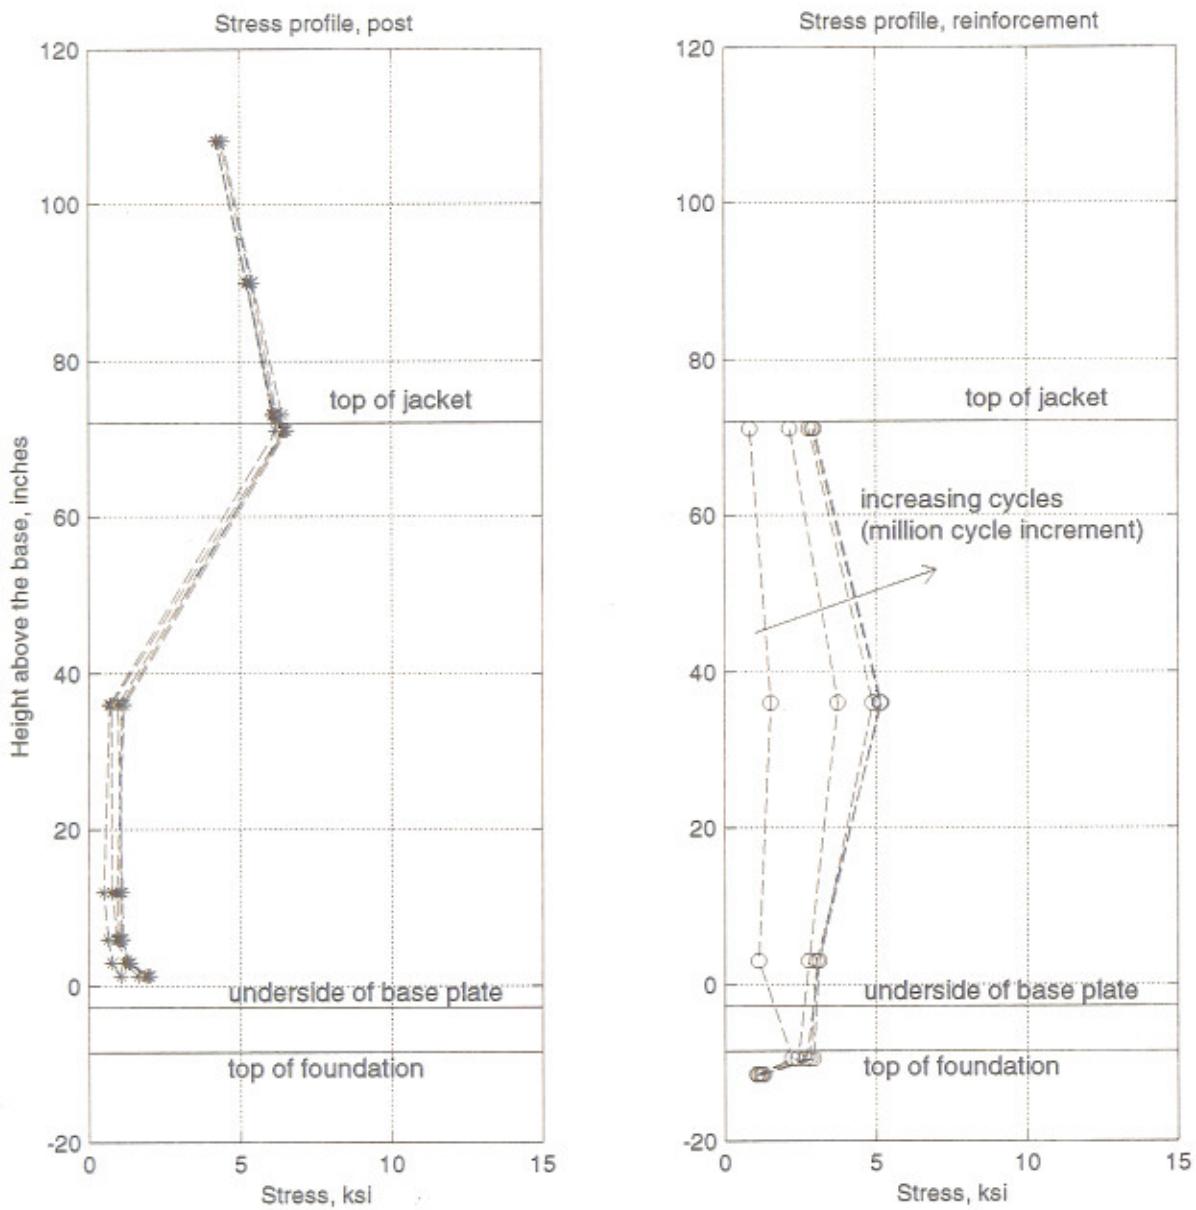
Figure 5.21: Stress profiles for Specimen CIP1

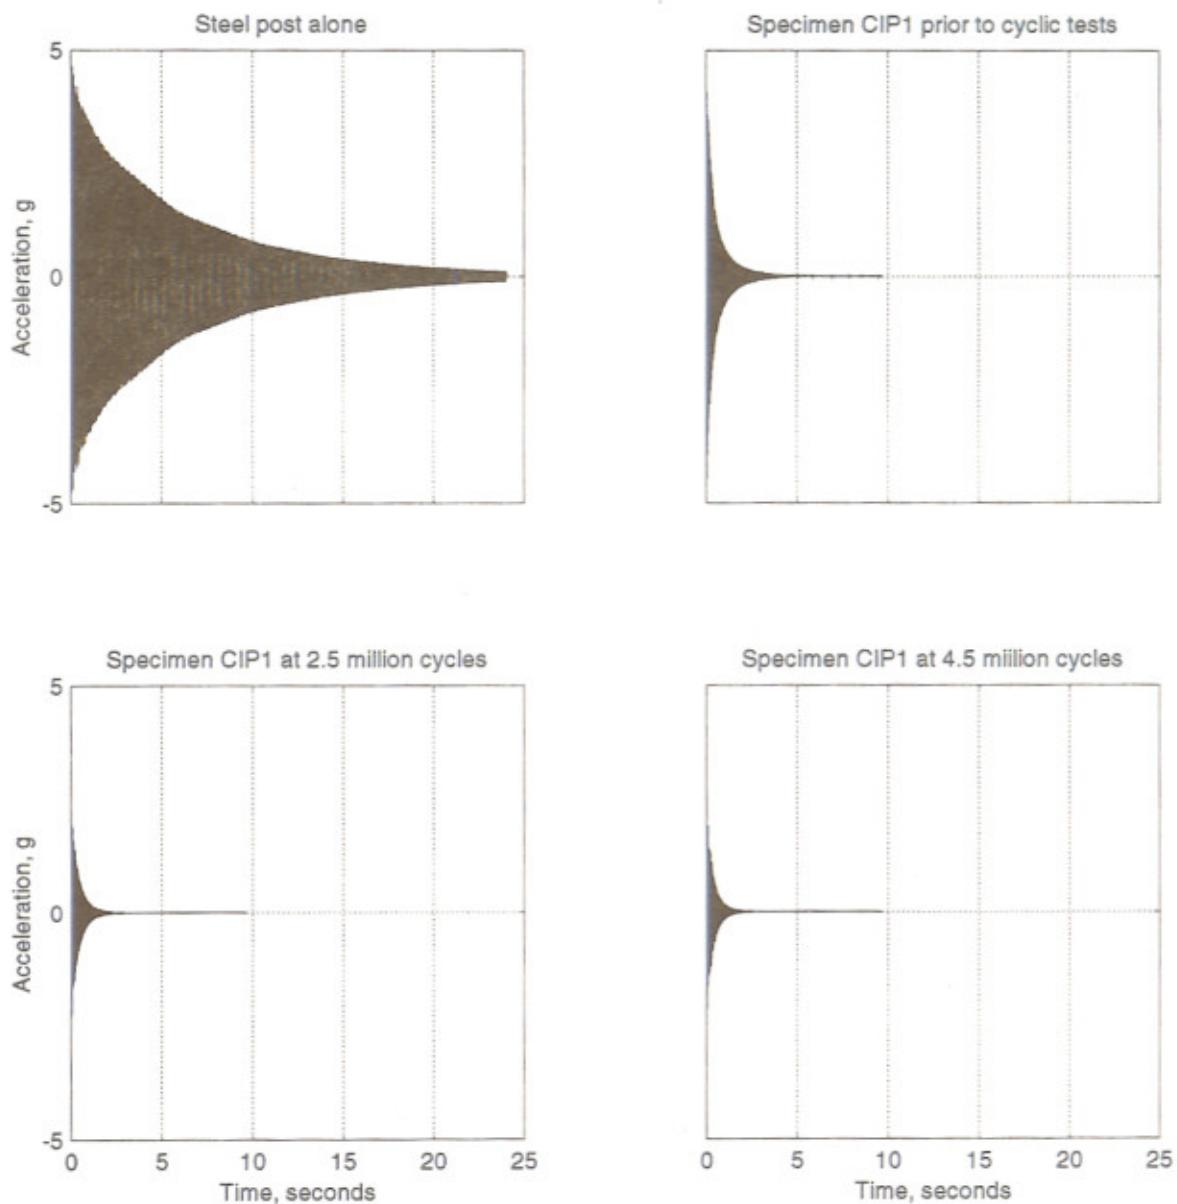
Figure 5.22: Free vibration acceleration response for Specimen CIP1

Pull-back test number	Cycle count	Frequency (Hz)	Damping (% critical)	Comments
1	0	13.1	0.3	Steel post alone
2	0	23.4	1.5	CIP1, prior to cyclic testing
4	2,500,000	21.5	1.6	CIP1, midway through the cyclic testing
6	4,500,000	20.0	1.8	CIP1, at the end of the cyclic testing

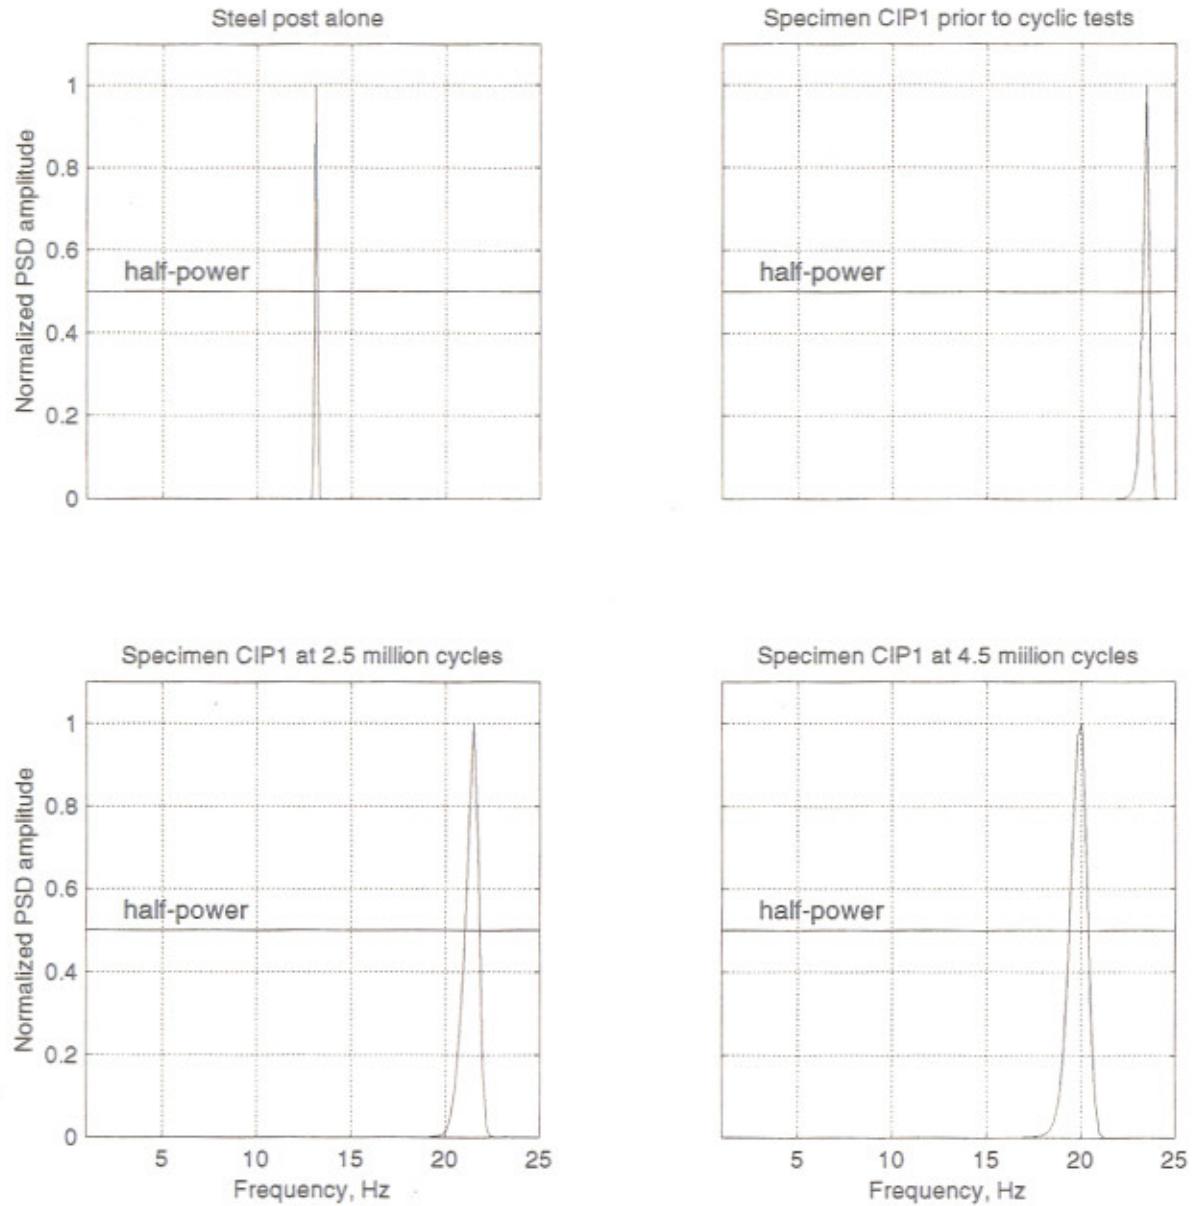
Figure 5.23: Acceleration frequency response for Specimen CIP1

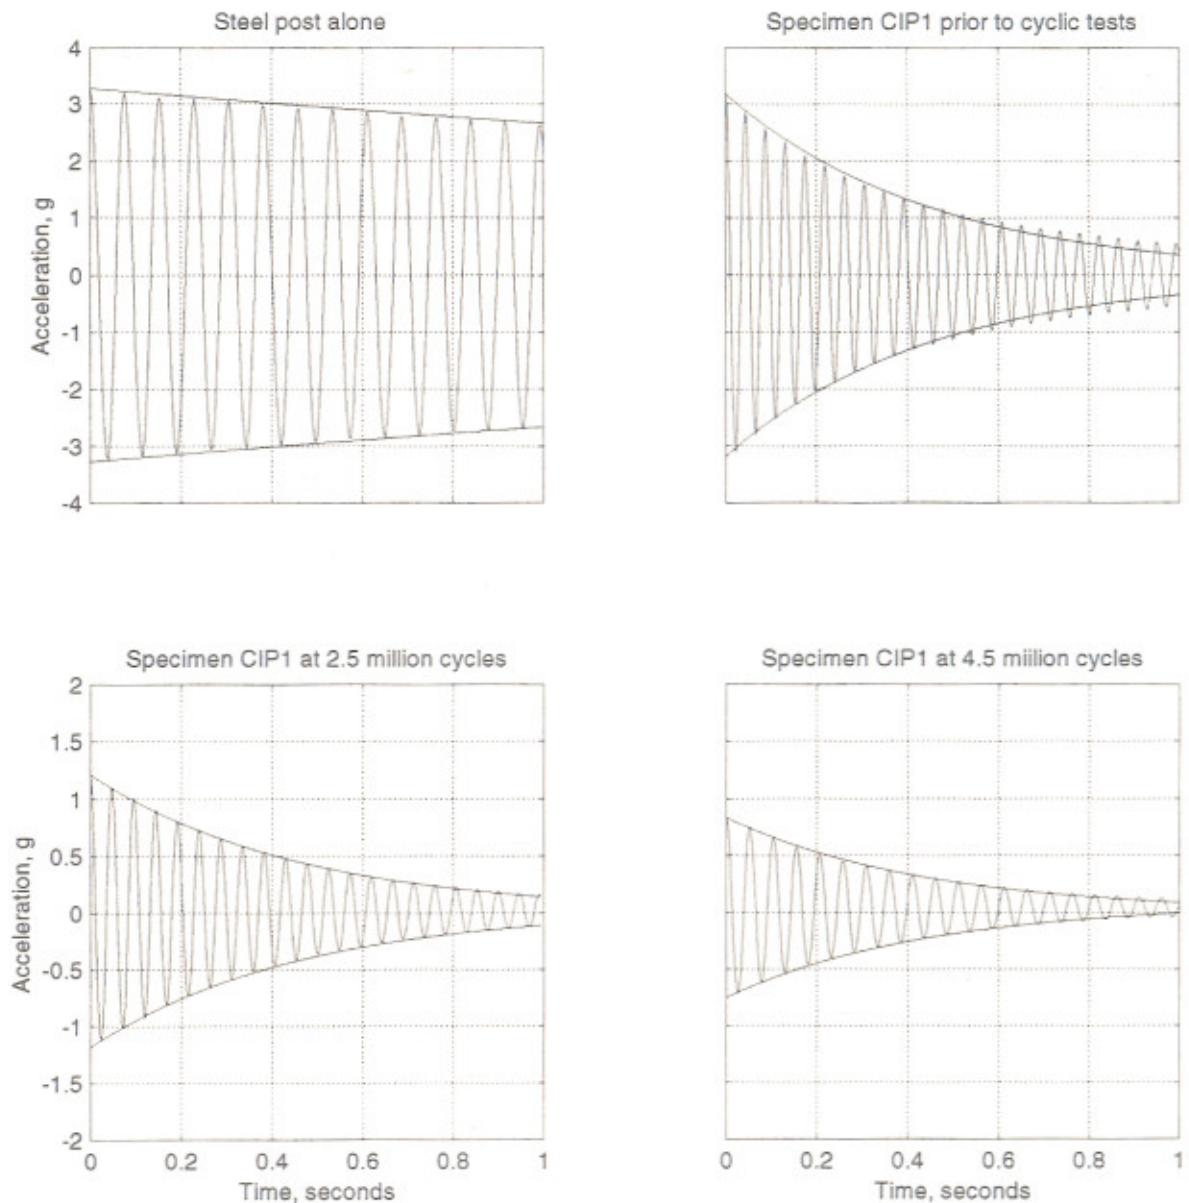
Figure 5.24: Analytical acceleration curve fitting for Specimen CIP1

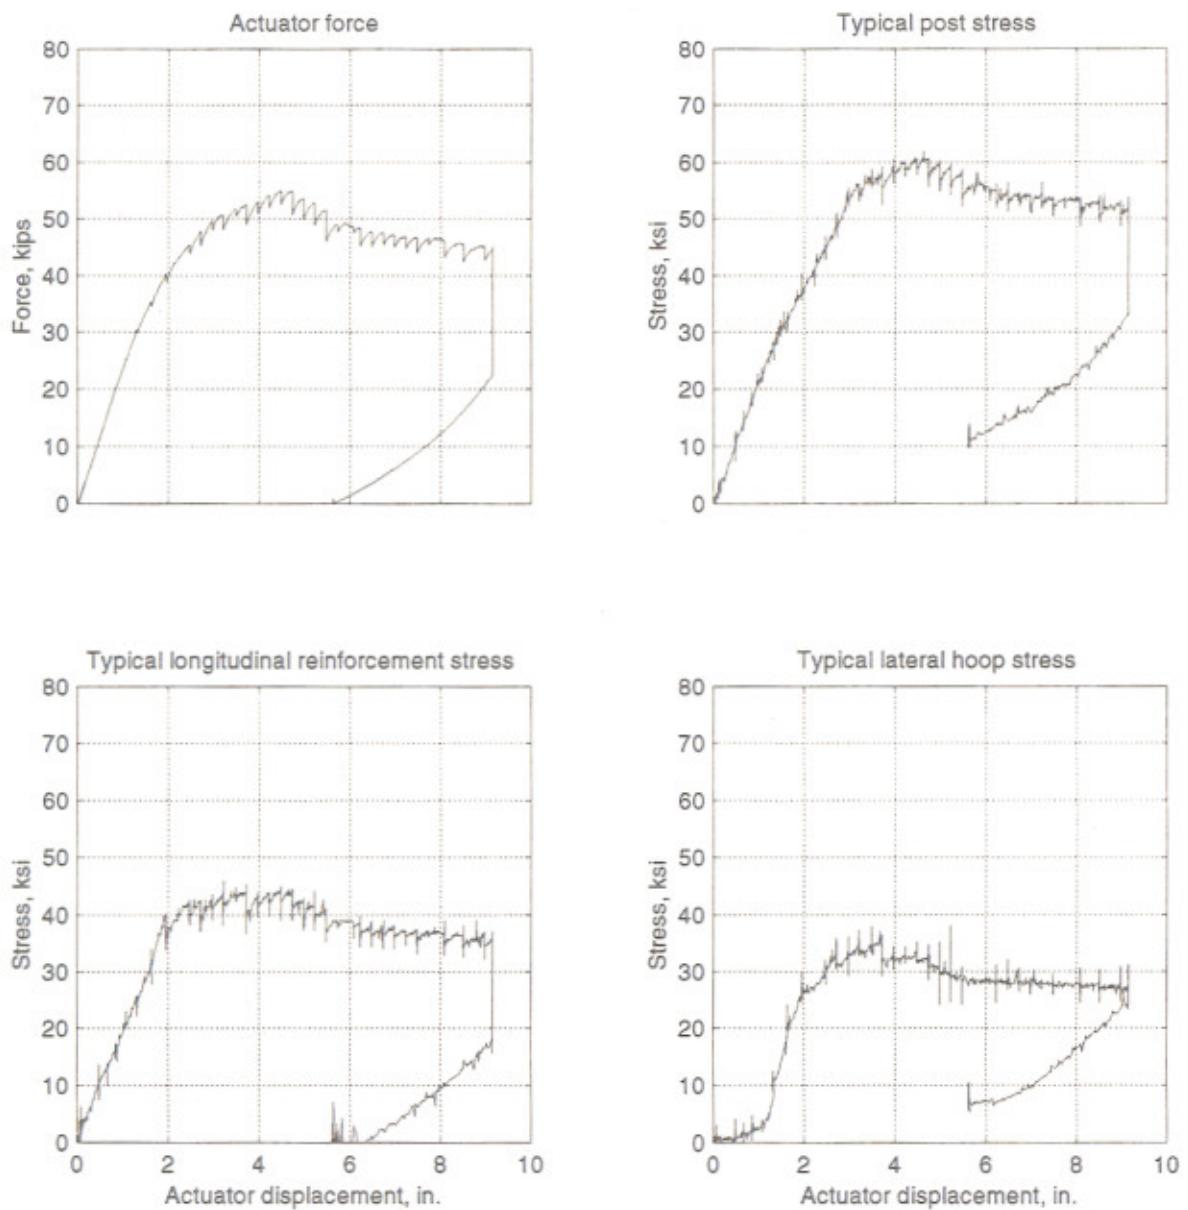
Figure 5.25: Push-over response for Specimen CIP1

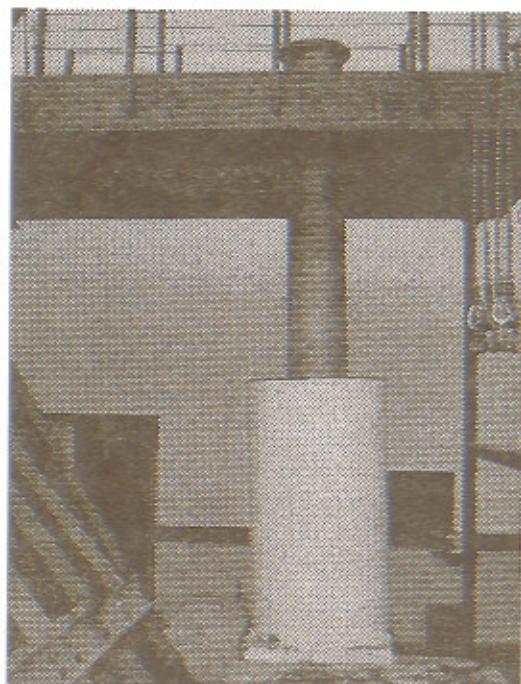
(a) Deformed configuration

Figure 5.26: Photos of Specimen CIP1 at the conclusion of push-over tests

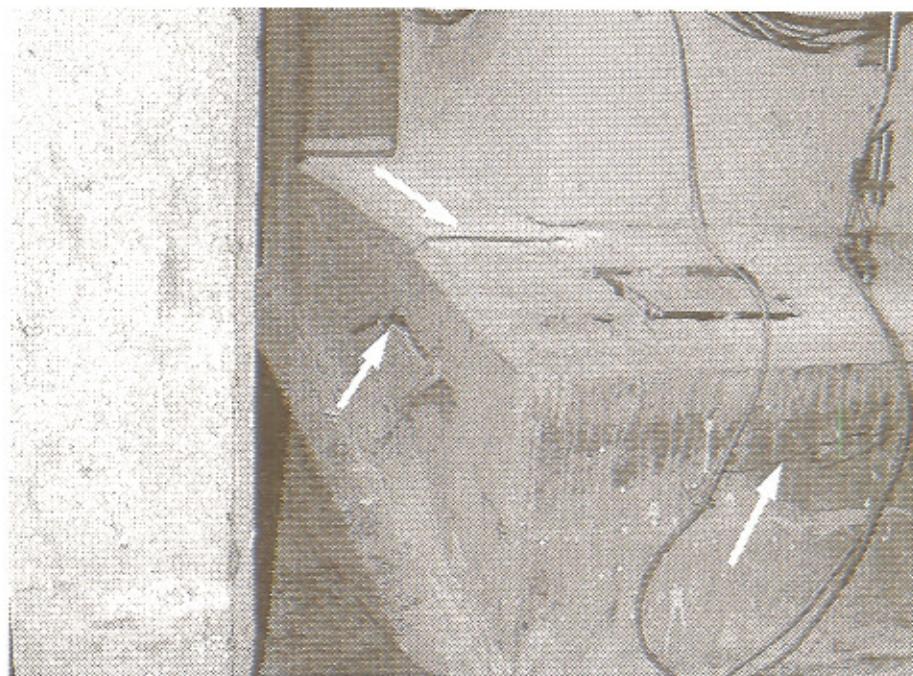
(b) Cracks in the footing
